Comparative Studies of Power Quality Issues in Offices and Residential Buildings

Vijender Kumar Begari*

Electrical Engineer, Al-Rashid Trading and Contracting Company (RTCC), Saudi Arabia

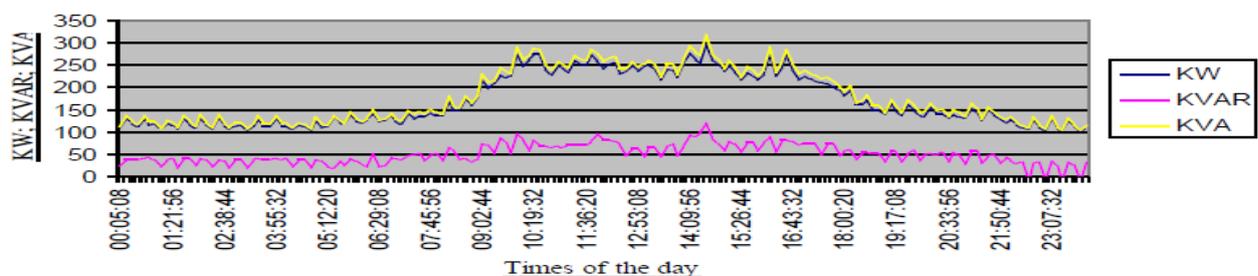
Fig. 1: The Pattern of the Powers in a Typical Working Day.

Figure 1 illustrates the total power consumption for a typical week day. As expected the maximum power was consumed during the peak time which is between 10:00 am and 4:30 p.m. The figure also illustrates the difference between the real and apparent powers. It should be noted that there are power

factor correction capacitors installed at the PCC and therefore the reactive power shown in Figure 1 is after the PF correction, hence its low level. The figure also shows that even when the power consumption is at minimum there is still certain amount of reactive power drawn.

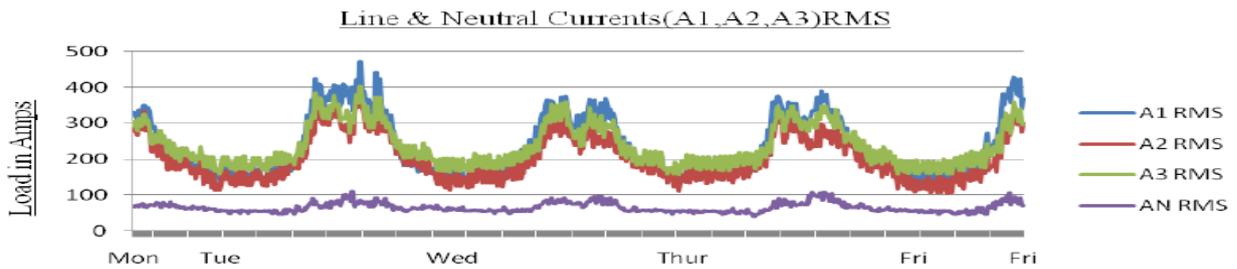
Fig. 2: Line and Neutral Currents of Office Building.

Figure 2 shows that the line currents varied widely because of unbalanced loading. Percentage unbalance is the maximum deviation from the average of the 3-phase voltages or currents, divided by the average of the 3-phase voltages or currents expressed in percent. The highest current unbalance loading was noticed to be 15% as shown in Figure 3. The current

unbalance occurs because the installation is constituted mainly by single phase loads and these loads are not distributed properly on the three phases. Poor load distribution may cause the system to become overloaded in a particular phase and have another phase underloaded. High neutral current leads to increase in power losses and overheating of equipments.

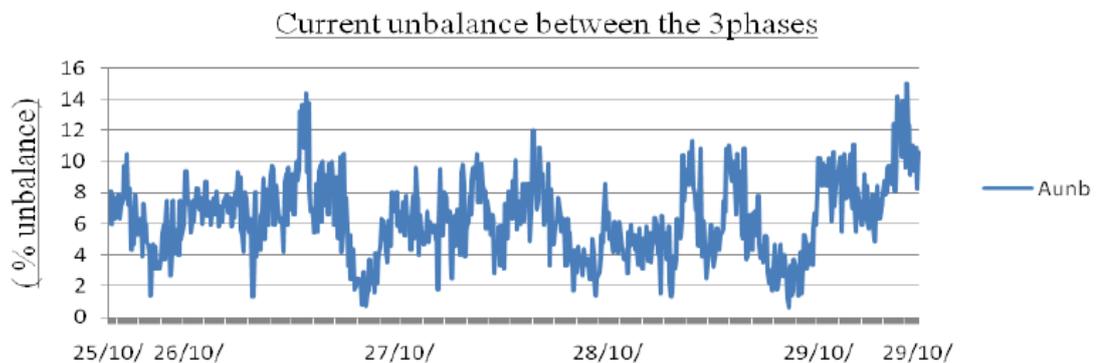
Fig. 4: Graph of Percent Unbalance of Average Current in Office Building.

The graph Figure 4 gives an idea of the possibilities to correct the problem, informing the times of the unbalance, making it easier to interchange loads between phases. The 100 A minimum on line A1 of the 28th and 200 A maximum on line A3 of the 29th might be as a result of little or no activities during the nights in the buildings. The weekdays of Wednesday and Thursday were not as high as that of Tuesday the 26th. The highest neutral current was observed to be 116 A (Figure 3). The high level of neutral current was due to the unbalanced loading between the phases and the harmonics caused by the non-linear loads in these buildings as noted in Figure 4.

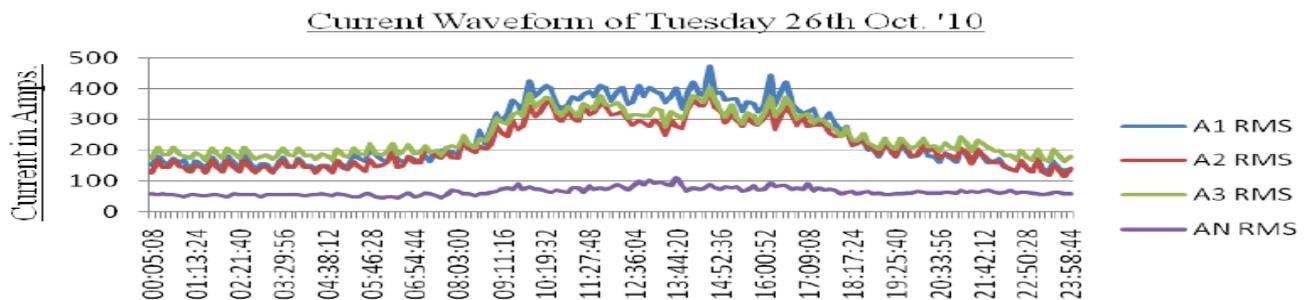
Fig. 5: Current Waveform of Tuesday Oct, 26th in Office Building.

However, the neutral conductor was noticed to be of the same size as the line conductors in this building. Even when the loading on the three phases looked

balanced between 00:05:08 and 09:02:44 (Figure 5) the neutral current was not zero. This is as a result of non-linearity of the load which consists of so many PCs.

shown in Figure 6. The loading between 9:11:16 and 17:09:08 was above 300 A, the phase-1 load was about 400 A during the period (between 12:36:44 and

14:00:00), and this was the time that the neutral current reached the highest peak of 116 A (Figure 5).

The 3rd harmonic was the highest, 15.5% (Figure 10). The neutral current A_n was very high as shown in Figure 5, as the phase current was as high as 116 A on the 26th October. This could be due to

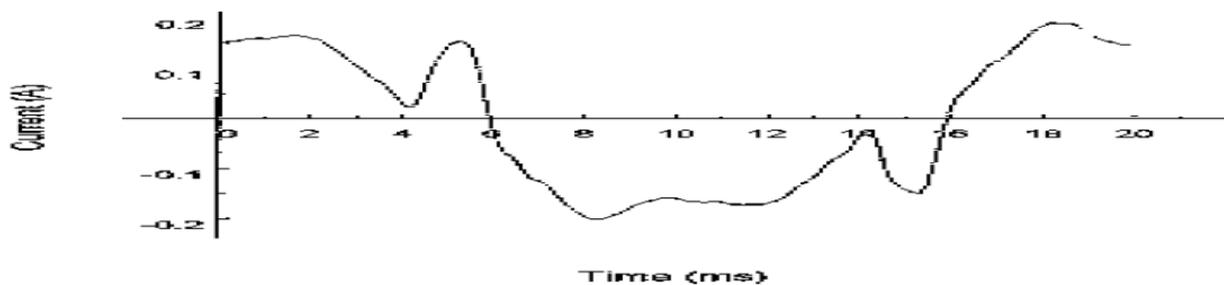
Fig. 6: A Typical Computer Load Current in Sleep Mode.

Although PCs should be turned off at night but the majority of the staff/students leave them on the sleep mode. PCs still draw the distorted current in the sleep mode as

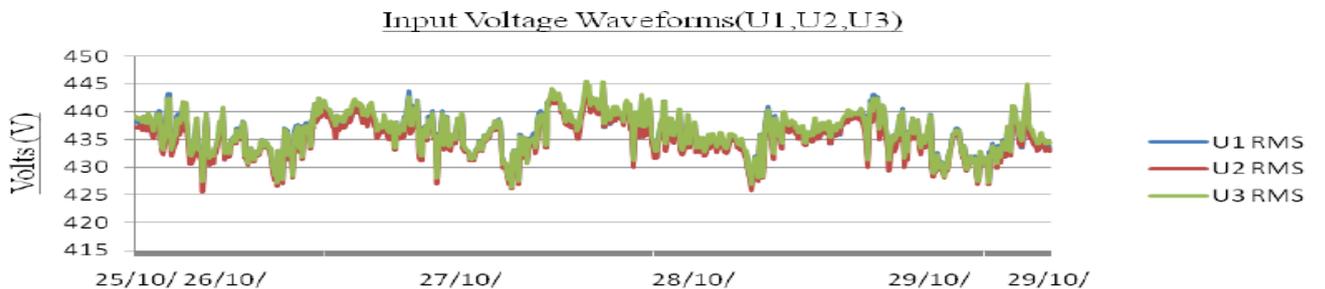
Fig. 7: Supply Line Voltages U1, U2, U3 for the Week.

The supply voltage (U1, U2, and U3) was high, as it varied between 427 and 445 volts on line-3 (U3) during the test period. This high voltage level could lead to unnecessary high consumption of energy even if the limits fall within the stipulated international standards EN50160. The phase voltages varied between 257.5 volts highest and 245.9 volts minimum on 27th October, this high voltage is unnecessary and leads to higher billing.

The THDV at the input was not high, it was 3.7% (Figure 7), and EN50160 puts this limit at $\leq 8\%$. But the individual harmonics presented different results; the 5th harmonic distortion of voltage was 8.7 instead of 6% limit as stipulated by EN50160, which showed that this limit was violated. The 7th harmonic distortion level was 1% and the standard limit is 5% all on phase-1 (Figure 8). This limit was not violated. All other harmonic levels were not violated. Mitigation of the high 5th harmonic should be by installation of passive filter tuned to that frequency.

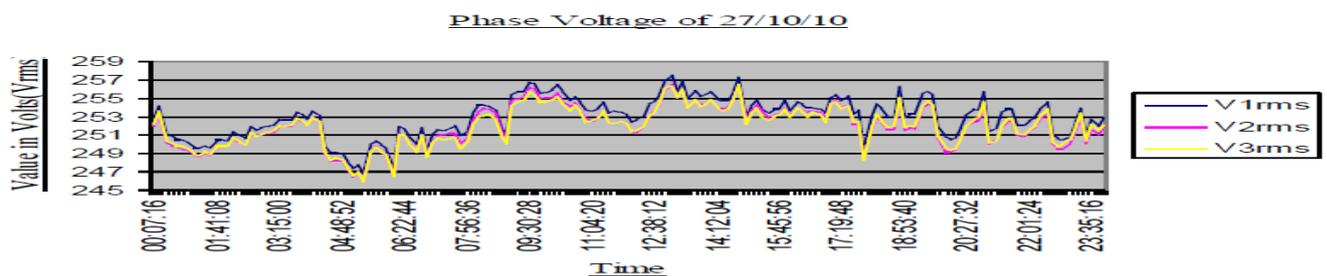
Fig. 8: Phases Voltages of Wednesday 27th, Oct (Next Day).

harmonic level was 8.7% (6% for this limit by EN50160) on phase-1 as seen Figure 8. The daytime is the usual period that most electronic equipments are in use in the building. Compatibility limit for the THDA should not be more than 8% for voltage and 20% for current THD, as established in EN-50160 standard [8]. The building has many electronic types of equipment which are the main sources of harmonic distortion especially the 3rd harmonic level. These are air-conditioning systems and elevators, many PCs and

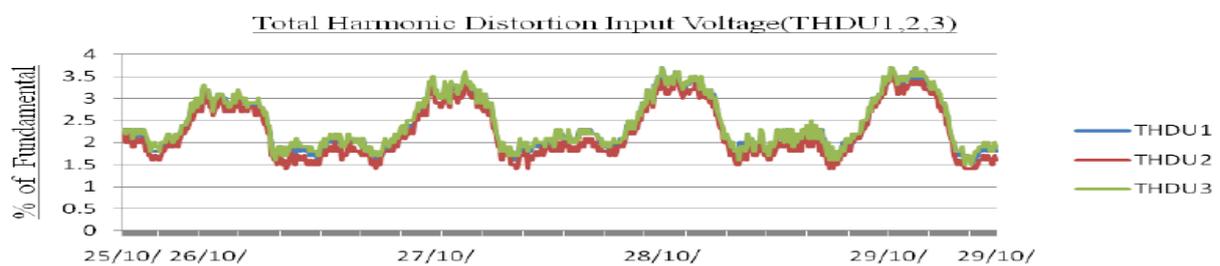
Fig. 9: Incomer Line THDU in Office Building.

After 5 days of measurement (25th–29th Oct 2010), it was shown that the voltage harmonic distortion at the input was not high. The maximum total harmonic distortion did not reach 4% as shown in Figure 9 during the data collection period.

The maximum was 3.7% on line-3 of 28/10/10. However, the standard's limit of $\leq 8\%$ for that harmonic order established in EN50160 was not violated [7-9]. For this period, the 7th harmonic maximum was 1.0% (5% for this limit) and the 5th

The neutral current for a balanced 3-phase and linear load should be zero. High neutral current cause overheating and the triple-N harmonic currents could pass over to the delta side of the delta-star transformer and circulate there, thus causing overheating even when the transformer is not overloaded. The current THDA was 18.7% on the 29th on phase-1 (Figure 9).

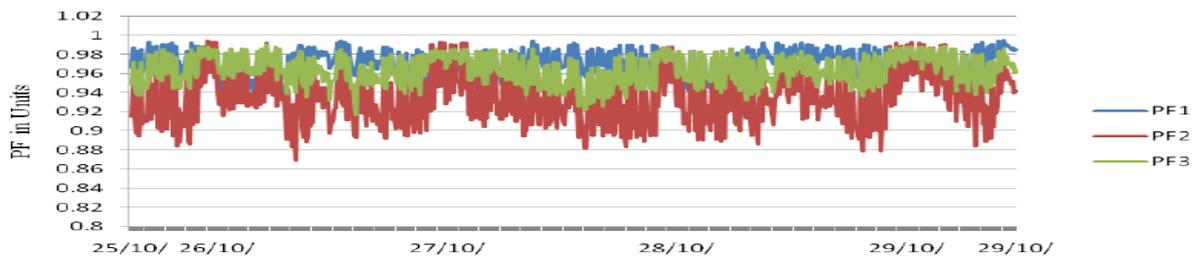
Fig. 12: Power Factor (PF) in All the 3-Phases.

The reactance (KVAR) of the inductive loads is 180% out of phase with the installed capacitors and the resultant sum is reduction in the reactive load and improvement of the PF. Figure 11 shows the period of the night that the reactive load were negative indicating that the fixed capacitors over-compensated for the inductive load. The power factor in each of the 3-phases is shown in Figure 12. The

power factor shown in the figure is the product of the displacement and the distortion factors. It can be seen that the phase-2 has the poorest PF compared to the other two phases. This could be due to the fact that this phase feeds most of the non-linear loads (e.g. computers). The phase-1 could be the one that feeds the lift and other linear loads.

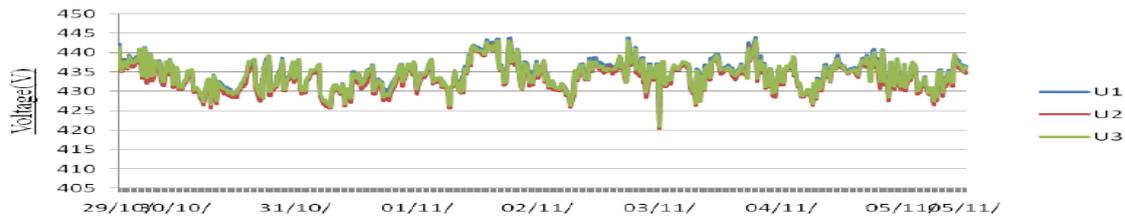
Fig. 13: Line Voltages of Residential Building.

A nominal rms voltage in UK is 240 V phase to neutral (Vrms), and 415 V phase to phase (Urms). The graph shown in Figure 13 illustrates the variation in the line voltages at different times of the test period (29th Oct–5th Nov’10). The data were collected during one week with a sampling period of 8 min. It could be seen from this graph that the voltages were not balanced.

They vary from 427.0 Urms on phase-1 and 445.0 Urms on phase-3. These recorded data at the input showed that the upper limit is outside the limits on the upper side ($\pm 10\%$) i.e. between 373.5 and 435.75 Vrms of the nominal line of 415.0 Vrms. The voltages in this building continually change as the load currents change leading to variations in the voltage, normally referred to as voltage variations. If the variations are within the acceptable limits, it is considered to be alright, but if

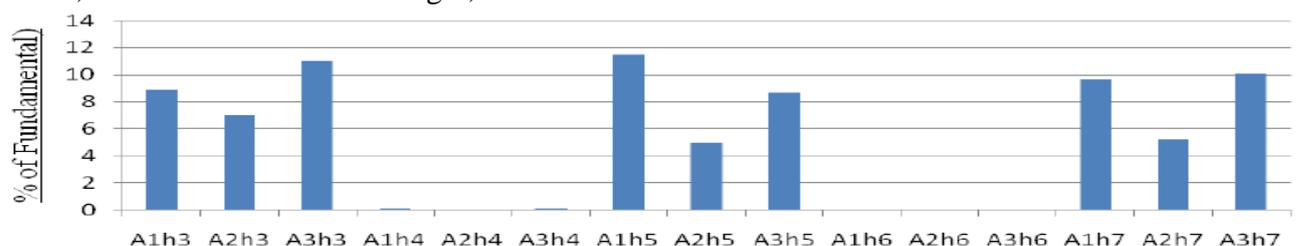
Fig. 14: Harmonics for Residential Building on Wednesday, 03rd November.

harmonic distortions are as shown below. The prominent were the 3rd, 5th and 7th harmonics, the 9th and other harmonics were very small (Figure 14). The 3rd, 5th and the 7th harmonics are high unlike the office buildings where the 5th harmonic was the only high harmonic to deal with. Mitigating these harmonics would require more than one passive filter and probably active harmonic filters.

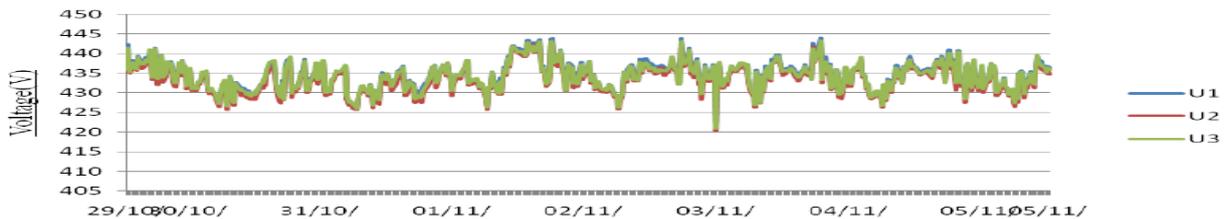
Fig. 15: Residential Building Incoming Line Voltages (U1, U2, U3).

If there is any anomaly in the wave shape it will be necessary to carry out stage by stage approach in order to identify the problem circuit. This could be accomplished by turning off different loads within the building while monitoring until the cause is identified. The supply voltage was stable and was in the range of 420 V minimum and maximal value was 444.8 V, (Figure 15). Voltage margins as

set in the UK are $\pm 10\%$ of 415 volts, line voltage that is from 373.5 to 435 V. There are different standards set for different countries. Although these measured voltages fall within the accepted standard of EN50160, they are high and could lead to unnecessary high consumption and subsequent overheating of cables and transformer. The transformer taps could be changed as an immediate relieve.

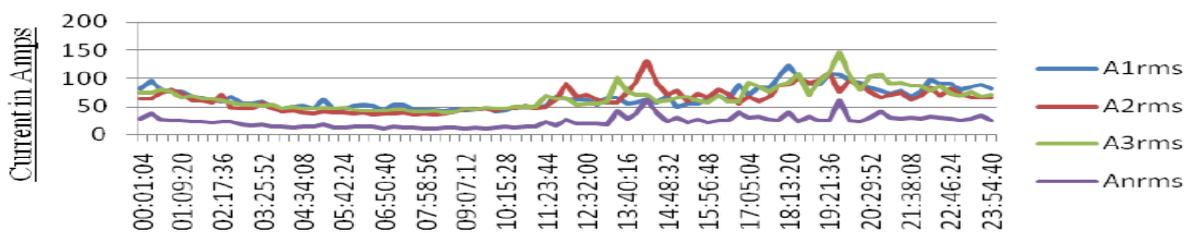
Fig. 16: Residential Building Load Currents of Wednesday, 03rd November.

The line currents are seen to be balanced, but the neutral current was quite high for the load currents. The loading of 3rd November was particularly studied because it has the highest neutral current as shown in Figure 16. There was balanced loading on the 3-phases between 00:35:12 to 10:49:36 hrs of 3rd Nov. But between 10:49:36 and 23:54:40; the unbalanced

loading was highest, and this occurred at 14:14:24 hrs. The loads were A1=62A; A2=131A; A3=72.1A; AN=62A. The neutral current (AN) should be zero, but had a minimum of 10.1A at 09:11:12 hrs (Figure 18). The 62 A on the AN is 47.3% of the highest load current of A1 of 131A, and 70% of the average load current.

This causes overheating of the neutral conductors, especially if the neutral cables are not adequately rated. If the harmonic currents are not removed, they flow back to the supply causing harmonic voltage distortion on the supplier due to supply impedance. The triple-N harmonics add up and circulate in the primary of the delta-star transformer and do not flow back into the system. However they increase the eddy current losses thus overheating the transformer. The age of the transformer could be greatly reduced.

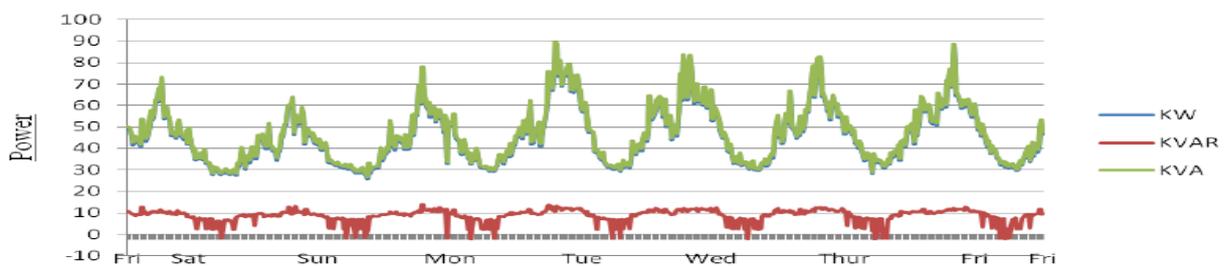
Fig. 17: Residential Building Loading of the Week (Friday, 29th October to Friday, 05th November).

Figure 17 shows that the highest apparent load of 89.64 KVA was recorded on 01/11/10 at about 19:17:20 hrs. This is a residential hall with minimum load in the morning unlike office building. This is an indication that the fixed capacitors over-compensated between the hours of 03:38:40 and 08:11:44 when the reactive load had reduced to minimum.

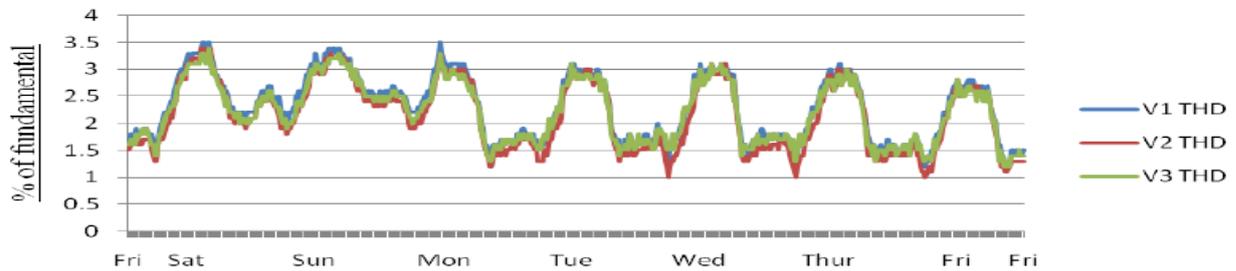
Fig. 18: Residential Building Total Harmonic Distortion of Voltage.

windings. This prevents the current summation to flow back into the system, but all other harmonics pass through. The load of November 3rd showed the neutral current (A_n) rms to be as high as the phase current (A_1) rms at 14:14:24 hrs. $A_1=61.8$ A; $A_2=131.0$ A; $A_3=72.0$ A and $A_n=62$ A. This high neutral current was as a result of the unbalanced loading of the phases and the presence of harmonics, especially the 5th (Figure 18).

The EN50160 gives the limit of 8% for THDV for LV system, in one week monitoring period and the highest THDV was 3.5% on phase-1. Therefore the limit is not violated^[7]. The individual voltage harmonics chart showed that the 5th and 7th harmonics are present as shown in Figure 18. The highest distortion was the 5th harmonic which was 3%, and the 7th harmonic was about 0.5%. The

international standard EN50160 gives the limits of 5th harmonic distortion to be 6%

and the 7th to be 5% [7]. These limits were not violated.

The results of the case study for residential building (29th Oct–5th Nov) had its highest measured short-term flicker on the 5th of Nov as shown below in Figure 18. At exactly 10:19:44 of the 5th of November the highest flicker was on 2nd phase (Pst2)=1. This happened only once during the test period of one week. Short-term flicker (Pst) is normally measured over a ten minute period, while Long-term flicker (Plt) is a rolling average of Pst values over a two-hour time frame. The value of the short-term flicker was 1, but not for upto 10 min, so it has not transgressed the International limits. The International Standards requires that the value of the short-term flicker severity index $Pst \leq 1.0$, and the value of the long-term flicker severity index $Plt \leq 0.65$ [11]. If the changes in the voltage are caused by load, and are less frequently than once per hour, or if the changes are the result of manual switching, then allowable values of short term flickers could be increased by 33%.
